How a Hydrostatic Pressure Test Proved the Effectiveness of an Innovative Secondary Containment System

Basic Concepts (BCI) PolySeam® Liner System Is Low-Maintenance and Leakproof

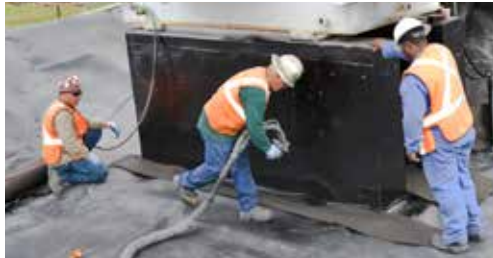
Sealing transformer pad with PolySeam.

The installation began by power washing the transformer pad and existing HDPE to create a clean surface. Once completed, installers vacuumed out the remaining liquid. BCI applied the PolySeam liner to seal the transformer pad first. They supplemented the area around the base of the pad with geotextile fabric and sprayed accordingly.

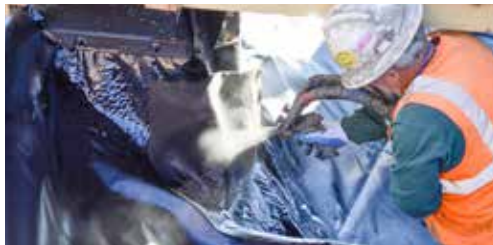
PolySeam easily bonds and seals irregular surfaces.

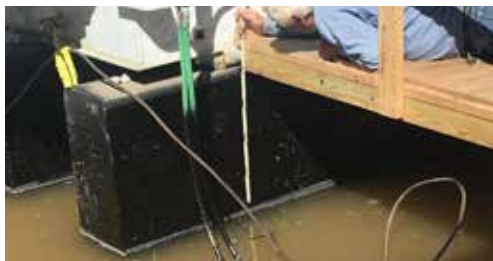
Performing hydrostatic pressure test

Hydrostatic pressure tests are commonly performed to check components such as pipelines, boilers and other pressure vessels for strength and leaks. To pass the test, the pit could lose no more than 1 inch of water in a 24-hour period, after factoring in evaporation.

Once the pit was half filled with stone, the team added water up to an agreed height. They established a control box outside the pit to evaluate evaporation. They added water and measured the starting height. After 24 hours, they measured the height again. They found only $\frac{1}{4}$ inch of water loss taking evaporation into account. The success of the project even surpassed the utility operator's high standards.
