Rehabilitating Faulty Seals and Leaks on Geodesic Domes

Failing Seals and Gap Issues

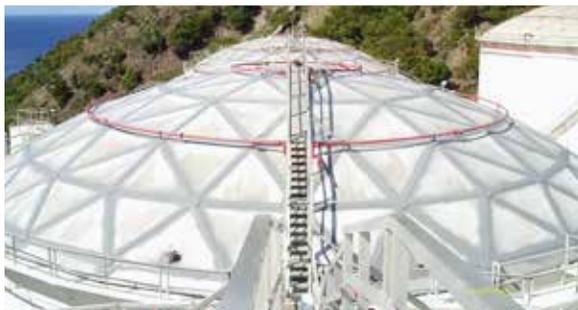
Multiple geodome roofs sealed to prevent future issues

Because it is flexible when dry, the coating moves with the tank roof, despite temperature and weather fluctuations. By effectively sealing the dome roof, noxious odors and vapor loss are substantially reduced.

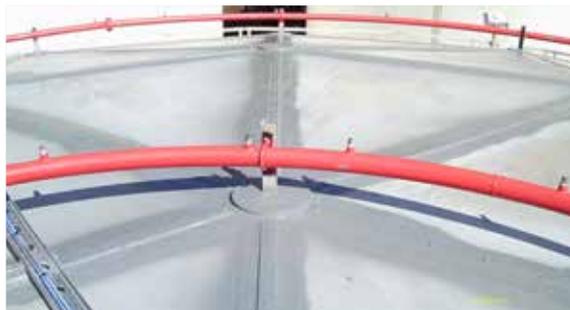
Gaps between panels completely sealed

Traditionally, repairing a geodesic dome involves replacing panels and seals or applying various forms of tape to help close the gaps, methods which are expensive and labor-intensive. Basic Concepts (BCI) offers an alternative solution with its SC-3900 spray-applied, flexible coating system. After cleaning the existing panels, the coating is applied directly over the seal, covering 4 to 6 inches on each side of the panel. With a short cure time, the coating application is relatively quick. Plus, it can be applied while the tank is in service, eliminating down time for the asset owner.
