Solving the Challenges with Rail Pans

Rail Pan Downtime

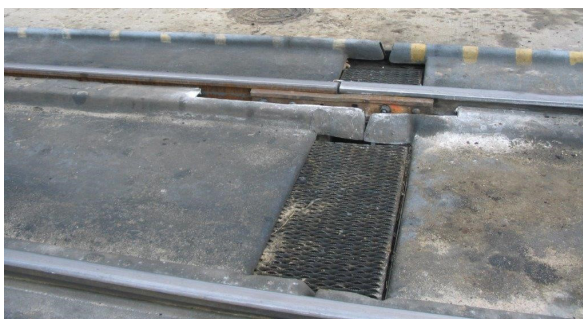
Rail pan prior to repair

Working with rail pans pose a unique set of challenges, all of which include downtime. Whether it be repairing, replacing, servicing or cleaning, the rail lines involved must be taken out of service. This can be hours, days, and even weeks dependant on the job.

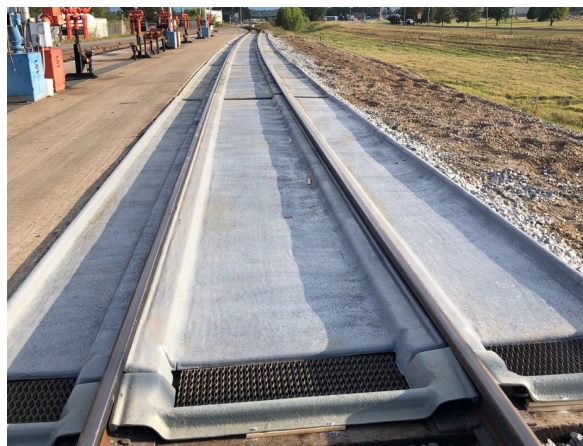
Rail pan after Justrite's SC-3900 coating

Justrite's SC-3900 and CR-3000 lining systems are highly chemical resistant and flexible. These provide a seamless, long-lasting solution that bridges cracks, seals voids, and can be installed on fiberglass, concrete, metal, and other rail pan materials. Their extremely fast dry times allow for a quick application, limiting rail downtime, eliminating cost, and often extending rail pan life by up to 10+ years. SC-3900 and CR-3000 handle a wide range of chemicals.

- 3000-4000 PSI tensile strength
- Elongation 100-300% (flexibility to handle track movement)
- High build to 60-1,000 mils pending application requirements
- Highly abrasion resistant
- Chemical resistant
- Zero VOCs
- 100% solids
- Non-slip grit upon request
